Beach Health Assessment

Waukegan Harbor South Beach

Waukegan, Illinois

Julie Kinzelman, PhD, MT (ASCP)
Racine Health Department
August 2013

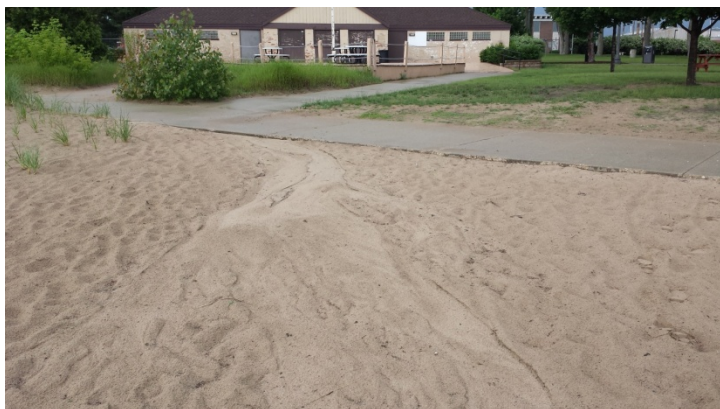
Another potential source noted, that could lead to the degradation of beach health, is direct surface water runoff from adjacent paved surfaces, which flows directly onto the beach and, when sufficient, into the near-shore waters. Studies have shown that storm water contains many contaminants, including *E. coli*. Surface runoff includes not only paved surfaces but rooftops, decking and other impermeable surfaces. The structure at the south end of the beach does not

have any guttering, delivering runoff to the beach area. This structure also appears not to be in service as portable bathroom toilets were located along the back side. Between 100 and 150 people were observed at the beach but it was indicated that usage can be much higher. It should be determined whether or not the number of toilets present is adequate for peak usage. Hand washing facilities should also be made available.

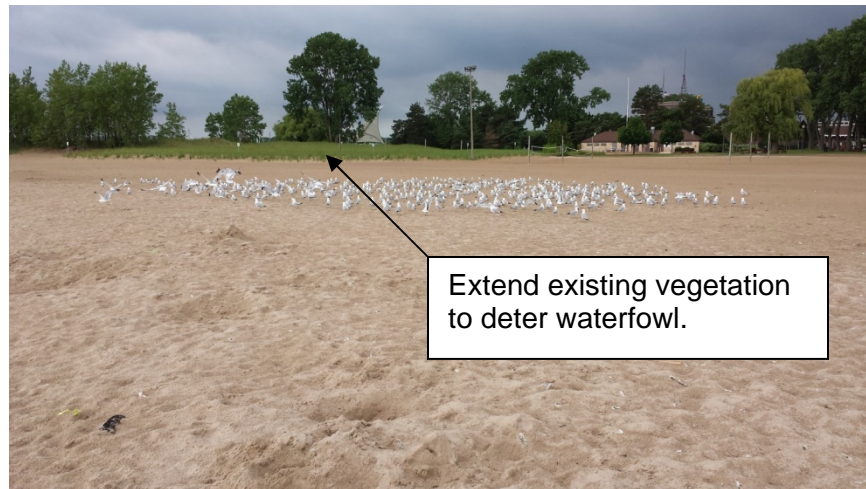
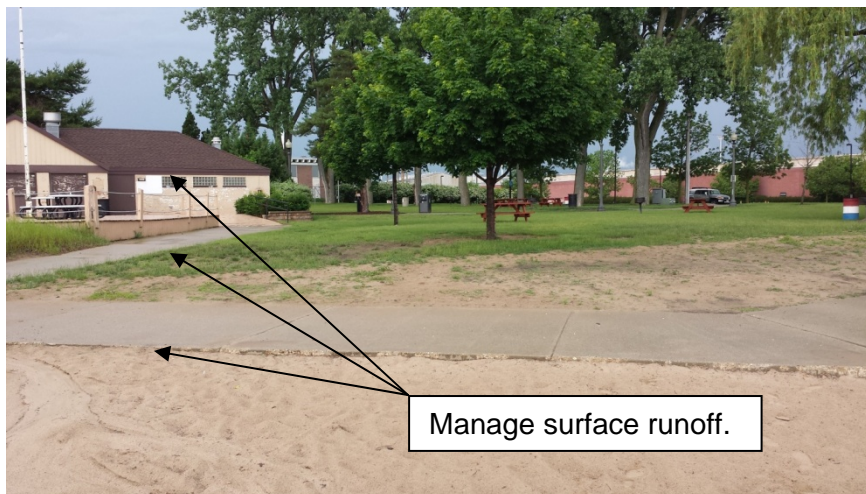
Another source of contaminants is excrement from waterfowl that utilize the beach, adjacent parking lots and lawn areas. Over 100 gulls were observed on 6/25/13 and significant goose feces were noticed on paved surfaces (but no actual geese). The number of gulls is likely greater than that observed as there were sizable amounts of feathers and tracks along the beach face. At the 8/4/13 beach visit the observer could get within one foot of the gulls, indicating that they are acclimated to humans and potentially being fed by beach patrons. The non-resident parking lot also had several pools of standing water in the absence of recent rainfall, which can attract waterfowl. While litter bins and solar trash compactors are abundant adjacent to the parking lot and in the picnic areas there were only two observed on the beach itself. Beach patron proximity to a suitable waste receptacle may contribute to the amount of litter on the beach, which can serve as a further attractant for gulls. A direct correlation between higher bird counts and higher *E. coli* levels has been documented.

Figure 1 (A – C) – Several hundred gulls and evidence of geese were observed (A). The bath house lacks guttering and there is no curbing to prevent sheet flow to the beach (B). The beach is flat, has a large swash zone and remains continually wetted (C).

Several measures may be utilized to reduce the amount of storm water runoff and decrease avian sources of *E. coli* and other contaminants from reaching the beach. These modifications would provide several layers of protection to the beach area and include: the placement of rain gardens and gutters adjacent to/on the structure at the south end of the beach, bio-infiltration swales along the interface between the paved footpath and beach, the expansion of existing native vegetation, beach nourishment, better defined public access, and other non-engineered Best Management Practices (BMPs). Some elements are meant to reduce the amount of contamination that the storm water runoff picks up and others are designed to intercept and treat storm water before it reaches the beach. Defined points of ingress and egress will keep the public out of naturalized engineered control measures while providing ease of access. Examples of problem areas at the existing beach that need to be addressed are shown in Figure 1 below. The purpose for remediating each issue and the potential benefits thereof are discussed herein.

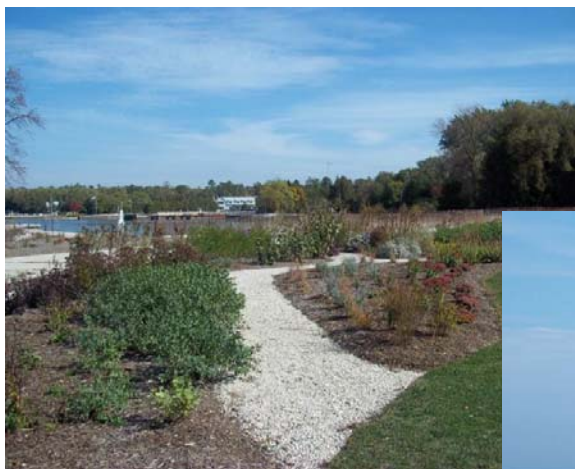
Examples of a rain garden installed along the border of a beach parking lot.

Rain gardens could be installed off the southeast and northwest corners of the structure on the south end of the beach to intercept and treat storm water runoff from the roof and patio areas. By preventing runoff from reaching the beach and/or near-shore water and filtering contaminants through an engineered soil mix, this type of design element will reduce one possible source of contamination. When properly constructed and maintained, rain gardens also provide temporary surface and subsurface storm water storage through the use of the engineered soils and a constructed depressed area. Rain gardens should be planted with native plants which will slow water flow, assist in infiltration and phytoremediation, improve aesthetics, and act as a vegetative buffer and a visual screen to discourage waterfowl.

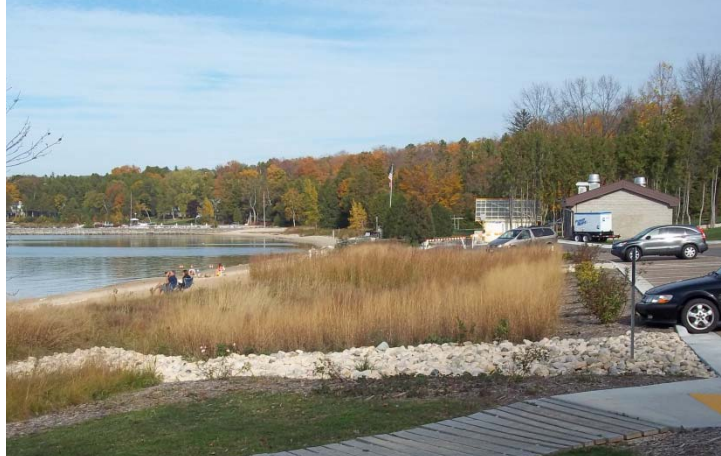
Infiltration swale vegetated with native grasses

Infiltration swales could be installed off the east edge of the existing footpath and parking lots to intercept and treat storm water runoff before it reaches the beach. By filtering contaminants through sand, this design element reduces another possible source of contamination. Infiltration swales also provide temporary surface and subsurface storm water storage through the construction of a shallow depression. Dune grass planted in the infiltration swales adjacent to the footpath would slow water flow, assist in infiltration and phytoremediation, and continue the natural aesthetic feel of the area. The “top end” of the infiltration swale (between the swale and the sidewalk) may be planted with native plants and shrubs that will act as a vegetative buffer as well as a visual screen to discourage waterfowl. The use of naturalized engineering measures would complement the existing dune and wetland areas that are in the process of being established. Engineered bio-filtration basins could also be used to capture and pre-treat stormwater from roadways to reduce the amount of “upstream” flow.

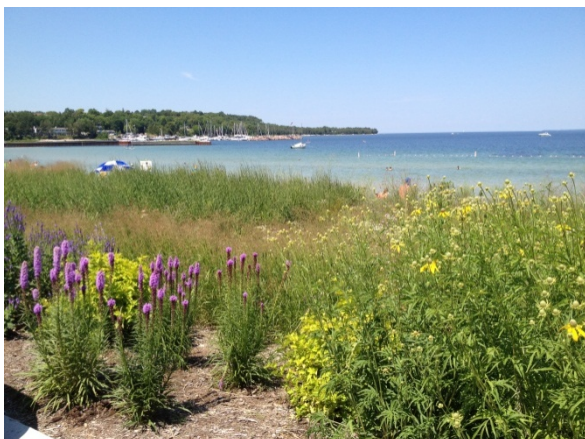
Example of native vegetation plantings

Both dune and wetland areas have been planted at this location in an effort to improve water quality, restore a functional ecosystem and discourage waterfowl from using this area. Extension of these area using shrubs, native plant species, and additional dune grasses will provide a better buffer between impervious surfaces (such as the foot path, road and the parking lots) and the beach, increase infiltration of surface runoff, extend the visual screen to discourage waterfowl

Should this recommendation be implemented, all plant species should be chosen that are native to Lake County, which is especially important along a valuable ecological resource such as the Lake Michigan shoreline. Choosing native vegetation will also improve coastal habitat by providing food and shelter for songbirds, butterflies and other desirable wildlife. Invasive species management should continue, e.g. herbicide treatment of Blue Dune Lyme Grass.

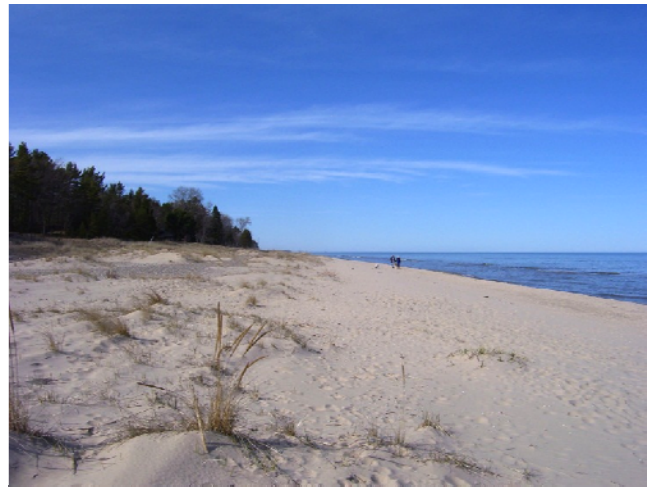
An example of what a “healthy beach” should look like. Note the small dune features, dune grass, and sloping beach.

The dune feature on the upper portion of the north end of the beach should be expanded as part of beach nourishment. Dune grass is extremely effective in stabilizing dune features by trapping blowing sand above ground and by holding sand in-place with its below ground root system. This will result in a stabilized beach area with improved aesthetics. A permit from the Illinois DNR would be required for beach nourishment.

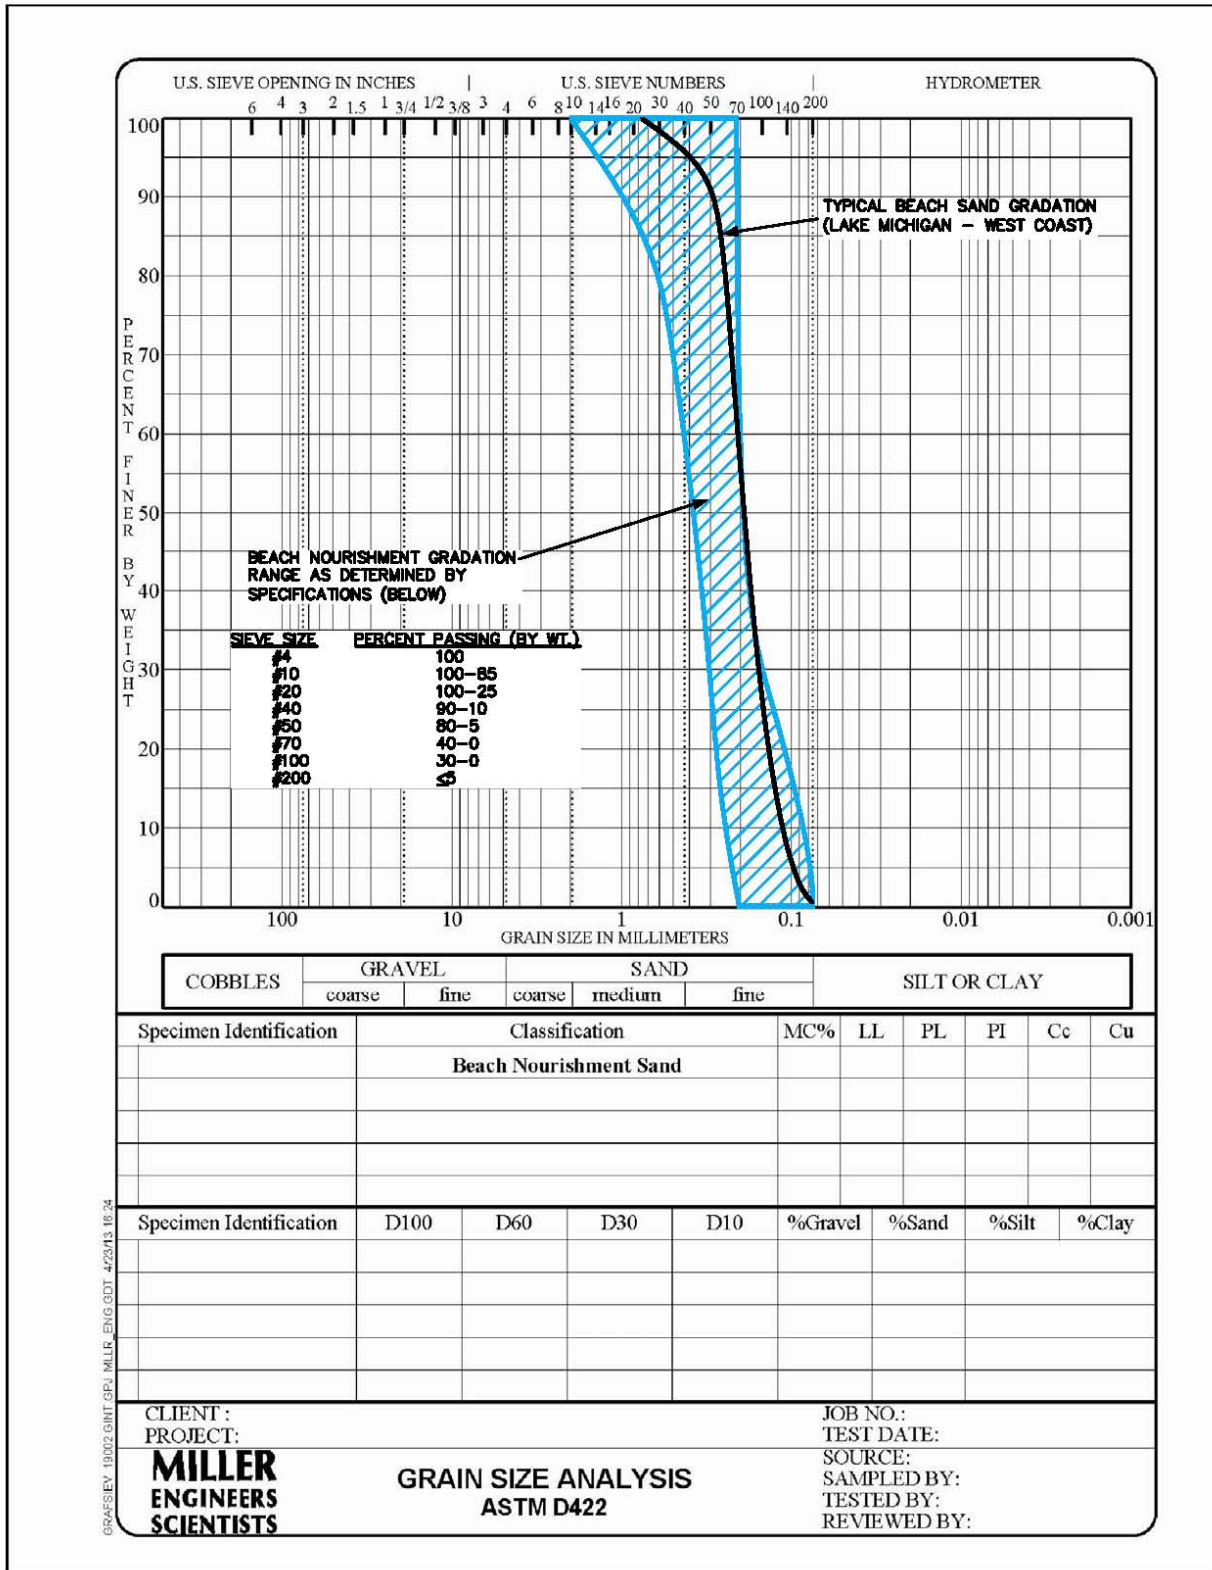
Typically beach nourishment sand has a specified gradation as shown in Figure 2. The slightly increased size of the sand particles specified promotes greater infiltration, which provides for a higher and drier beach. Larger sand particles are also less susceptible to wind erosion, decreasing the amount of sand that will be blown off the beach.

Figure 2 – Example of sediment grain size analysis showing typical Lake Michigan and nourishment gradation ranges.

Beach nourishment is also recommended along the entire length of the shoreline, most critically at the north end. The purpose of beach nourishment is to steepen the beach to decrease “ponding” and to raise more of the beach above the water table, which results in a drier beach. Because bacteria do not survive well in dry conditions, beach nourishment helps to decrease bacteria levels in the sand.

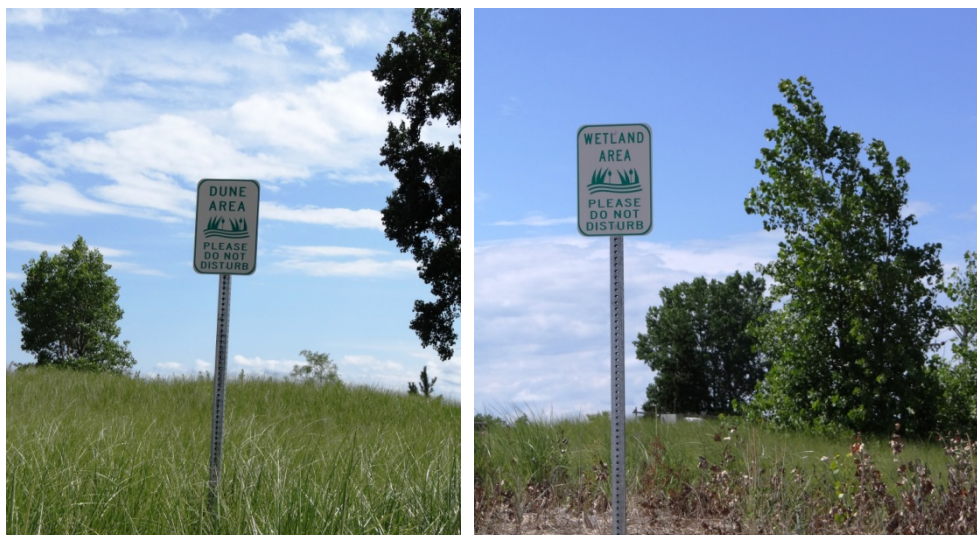
Examples of existing dune and wetland signage, which are currently only beach facing.

- Install bidirectional signs (and provide enforcement) in the park and beach area reading:
 - “Don’t Feed the Birds”
 - “No Pets Allowed”
 - “Pick Up Trash”
